Lot xxxxxxxxxx, Spring Hill, TN

A+ HOME INSPECTIONS

PRE-DRYWALL INSPECTION REPORT

Evaluation of property at: **Lot xxxxxxxx, Spring Hill, TN**
Inspection is performed for: xxxxxxxx
Time of the inspection was: June 21, 2019 10:00 AM

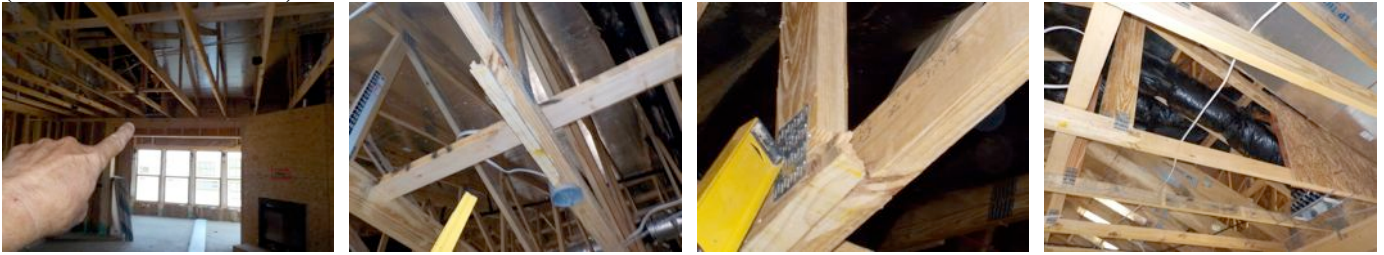
1. Roof truss A8 above middle of opening to rear sunroom was broken-off and field-patched with OSB (oriented strand board).

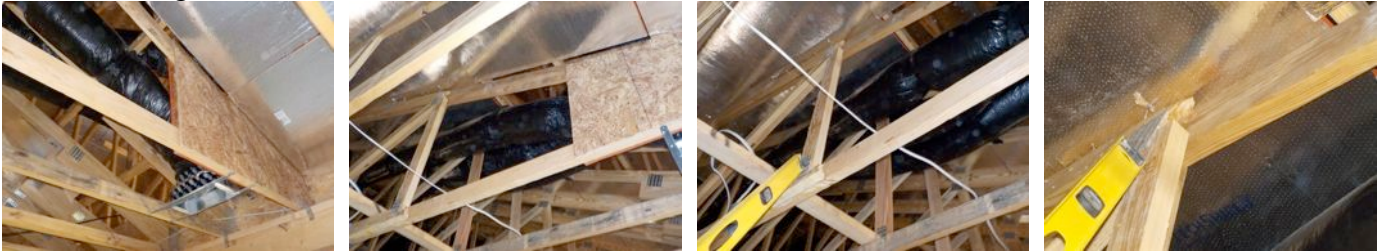
- 2.
3. No field modifications are allowed without written approval from the roof truss engineer.
4. Local building codes should be involved in this structural defect.

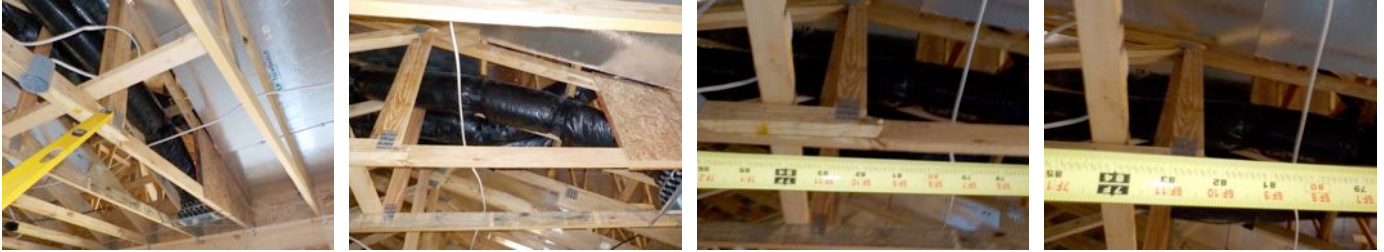
- 5.
6. The rear 7 feet of this truss was broken off and missing.

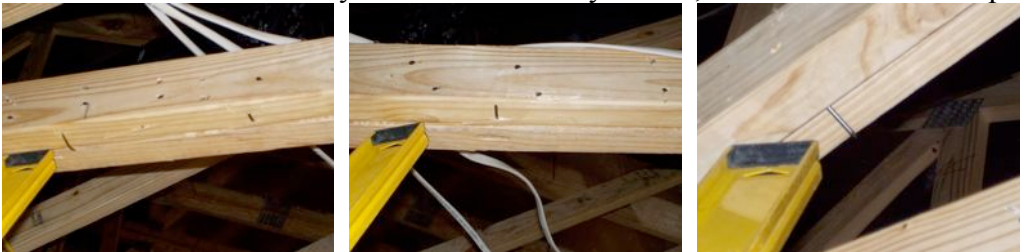
- 7.
8. A piece of another roof truss was scabbed onto the side of this one.
9. Some badly damaged roof trusses cannot be fixed, and must be replaced.
10. Several nails used to scab the new piece onto the broken truss missed, and were sticking out of the bottom of the roof truss where they are not structurally secure, and would cause humps in the drywall ceiling.

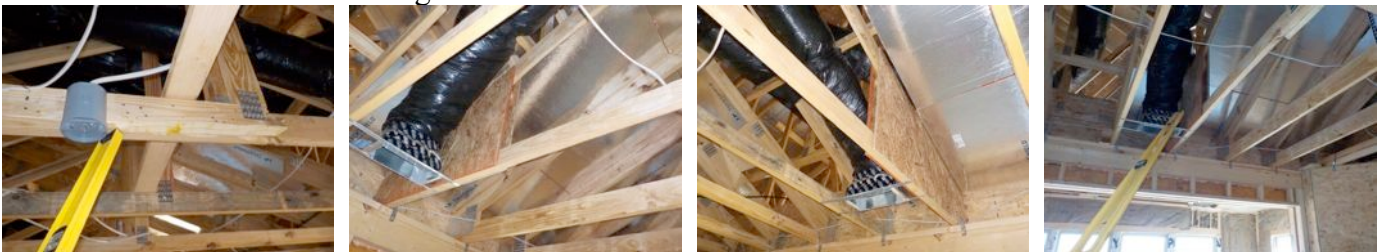
- 11.
12. Bottom chord of roof truss was uneven where scabbed.
13. Even a slightly sagging truss could cause a dip in the drywall ceiling where a lot of daylight from the sunroom will shine across ceiling.

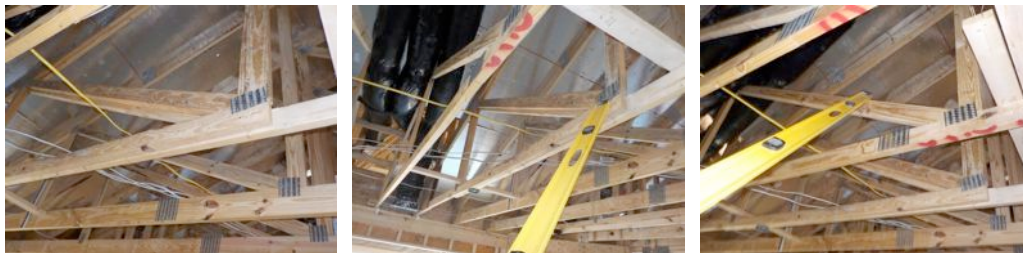
15. Where did the new section of roof truss that was scabbed onto the side of the broken truss come from?

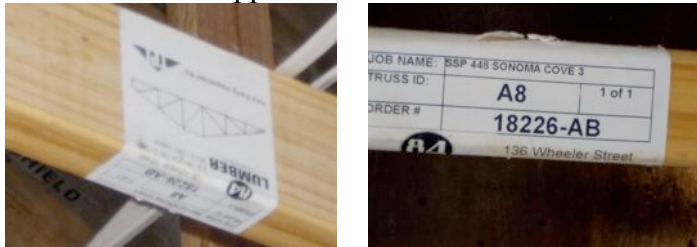
16.
17. The roof trusses appeared to come from 84 lumber.

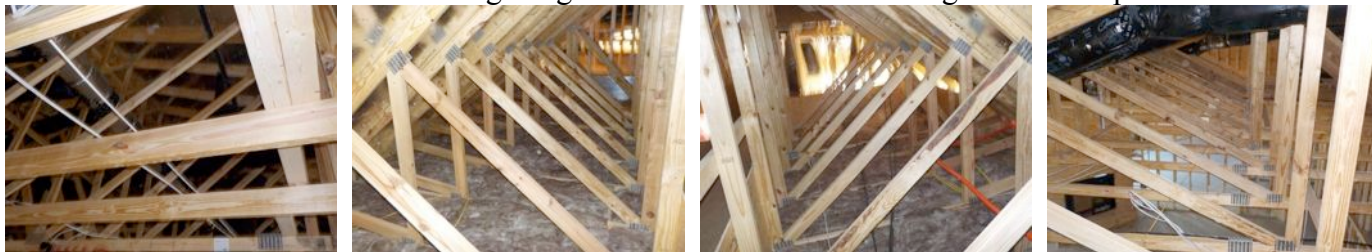
22. Please note: **Depending on the extent of damage, some trusses cannot be repaired and must be replaced.**
23. Provide detailed letter from truss design engineer with his State of TN engineer’s stamp.

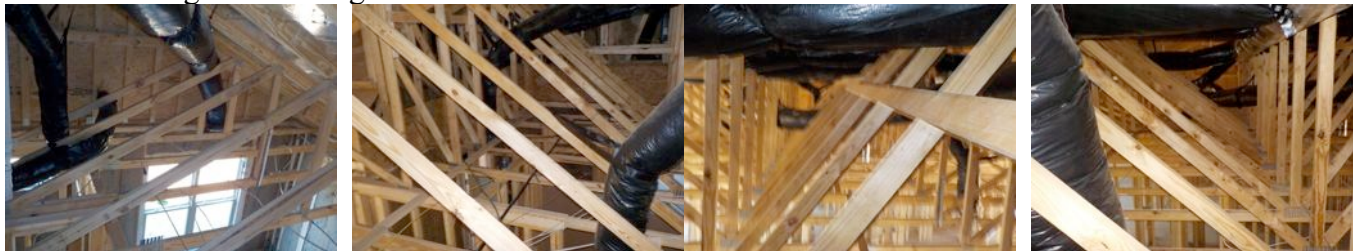
24.
25. Lateral bracing was missing from a lot of the roof trusses.

26.
27. Permanent, continuous lateral bracing should be installed per roof truss engineer. It is usually applied to the diagonal compression webs of the roof trusses.

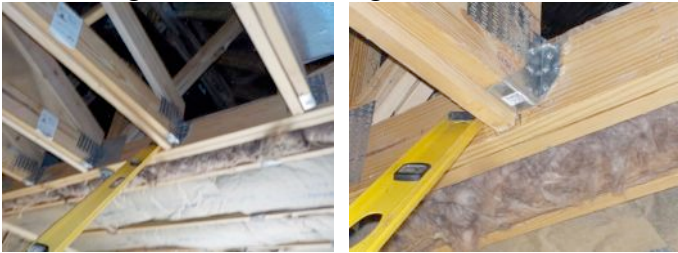
28.
29. In front right bedroom ceiling, bottoms of roof trusses were not even with bottom of beams.

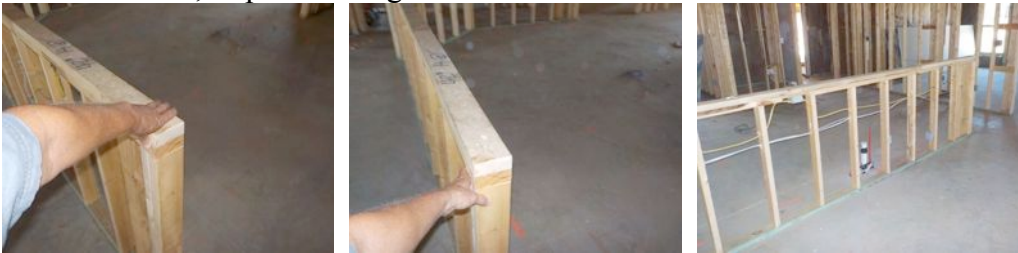
30.
31. End of the short wall was very loose in kitchen. Reinforce end of wall with metal Simpson straps, other metal fasteners, or posts through floor.

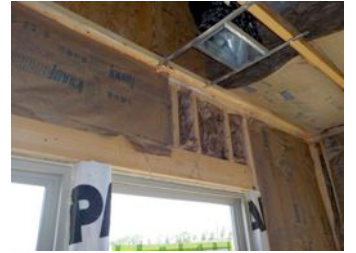
- 1. Paper vapor barrier was missing from several pieces of wall batt insulation, like above front door in right front bedroom, above some windows, and others.

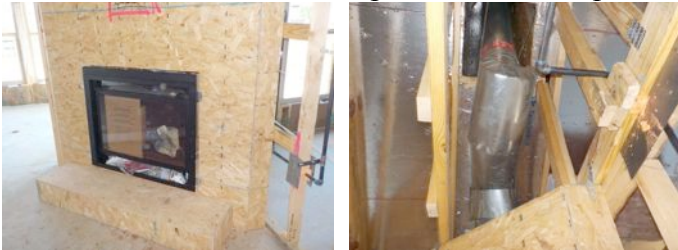
1. Ensure dust and debris off top of how firebox prior to drywall.

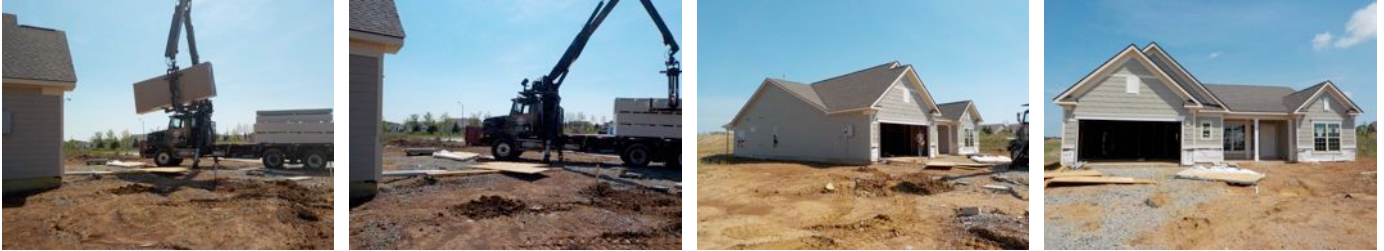
1. Building codes 401.3, 406.3.5 and 1806.5.5 require the ground immediately adjacent to the foundation to be sloped away from the building at a continuous slope of 5% (6" minimum drop) for a minimum distance of 10 feet.

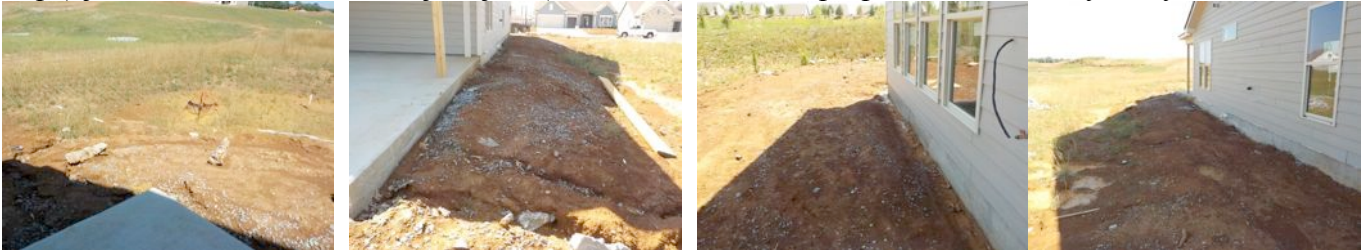
- 2.
3. Building code 1803.3 Site grading states. *"The ground immediately adjacent to the foundation shall be sloped away from the building at a slope of not less than one unit vertical in 20 units horizontal (5-percent slope) for a minimum distance of 10 feet (3048 mm) measured perpendicular to the face of the wall."*

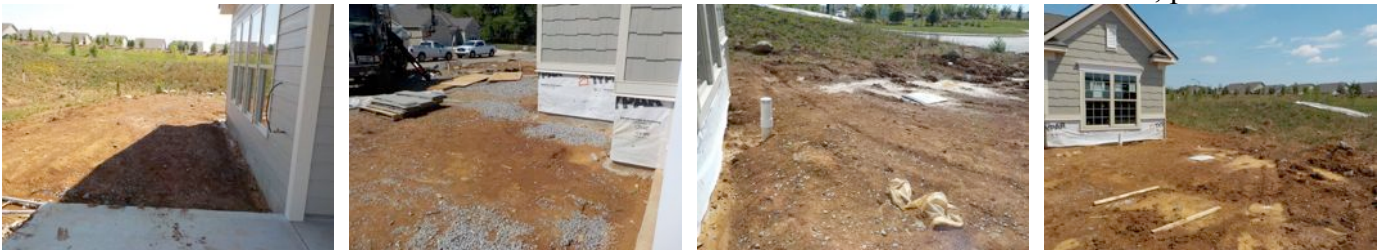
- 4.
5. I recommend the ground slope away from the house at least 1" per foot for at least 10'-0".
6. Please grade yard now to drain away from the house at a minimum of one inch per foot for ten feet minimum on all sides of the home. Do not wait until house is finished to grade it properly.
7. Presently, it is flat around the outside of the house, where water puddles are standing when it rains.
8. Ground will need to SLOPE AWAY from front of the house for AT LEAST 10 FEET too, per codes.

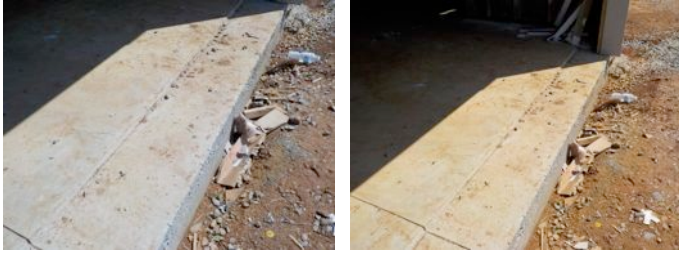
10. Do not pour driveway over any wood, as it may invite termites. Thicken driveway at garage slab to reduce chance of settling.
11. Ensure concrete outside of the step-up at garage door slopes out AWAY from garage to ensure water does not enter garage.

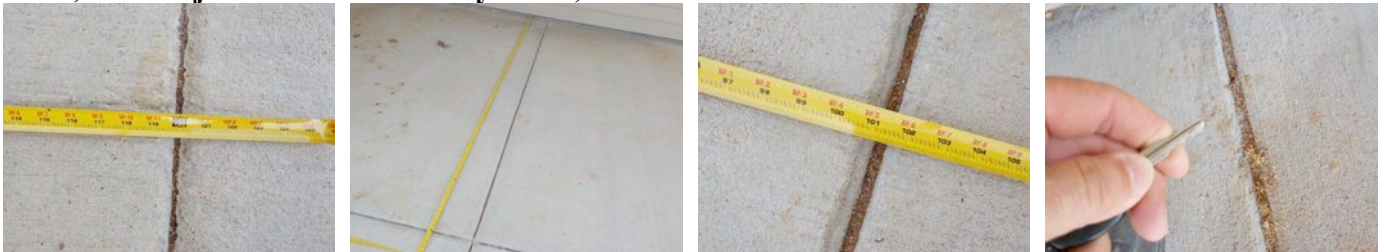
15. There are not enough proper control joints in the concrete slabs. There are NO control joints in the rear porch floor slab, and there should be. Control joints are planned for cracks, which allow for movements caused by temperature changes and drying shrinkage. In other words, when the concrete cracks, you want to have an active role in deciding where it will crack and that it will crack in a straight line instead of randomly. According to the Portland Cement Association, control joints should be placed at two times the concrete slab thickness in feet for a maximum aggregate size of less than 3/4 inch. Therefore, **if slab is 4" thick, control joints should be every 8 feet, in both directions.**

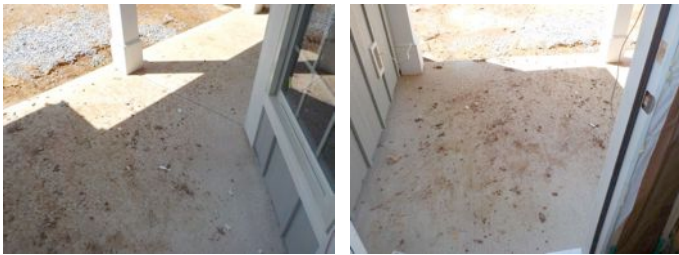
- 16.
17. **Cut joints deep enough. Cut joints 25% of the depth of the slab.** A 4" thick slab should have joints 1" deep. Grooving tools cut joints in fresh concrete. Saw cut cuts joints as soon as the concrete is hard enough that the edges abutting the cut do not chip from the saw blade. Joints can be saw cut into concrete after it is cured too.

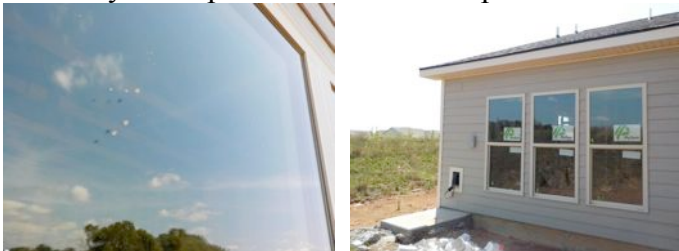
1. Carefully clean paint off windows to prevent scratching.
