Lot xxxxxxxxxx, Spring Hill, TN

A+ HOME INSPECTIONS

PRE-DRYWALL INSPECTION REPORT

Evaluation of property at: **Lot xxxxxxxx, Spring Hill, TN**
Inspection is performed for: xxxxxxxx
Time of the inspection was: June 21, 2019 10:00 AM

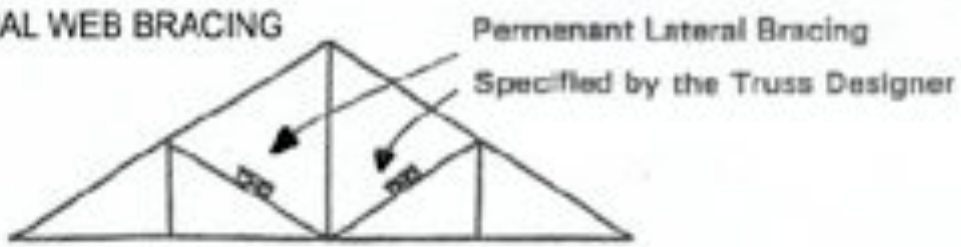
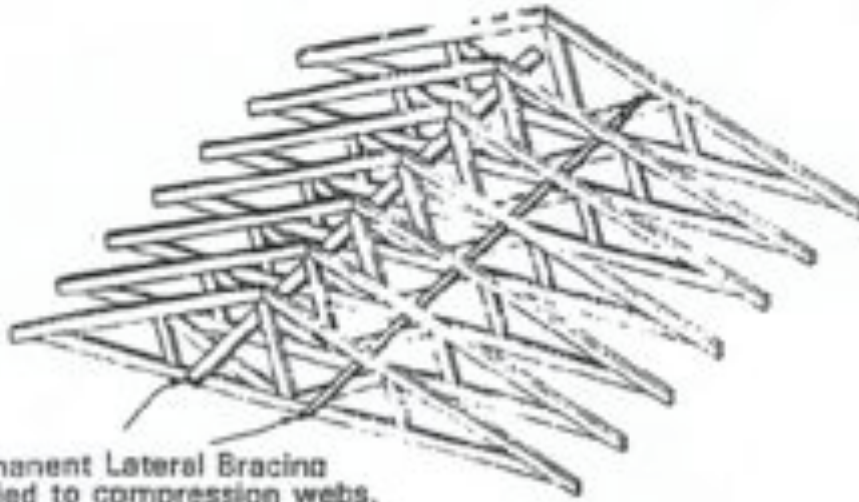
LATERAL WEB BRACING

24.
25. Lateral bracing was missing from a lot of the roof trusses.

26.
27. Permanent, continuous lateral bracing should be installed per roof truss engineer. It is usually applied to the diagonal compression webs of the roof trusses.
